AMMRC TR 80-15

CHARACTERIZATION OF TURBINE CERAMICS AFTER LONG-TERM ENVIRONMENTAL EXPOSURE

GEORGE D. QUINN

Date Published - April 1980

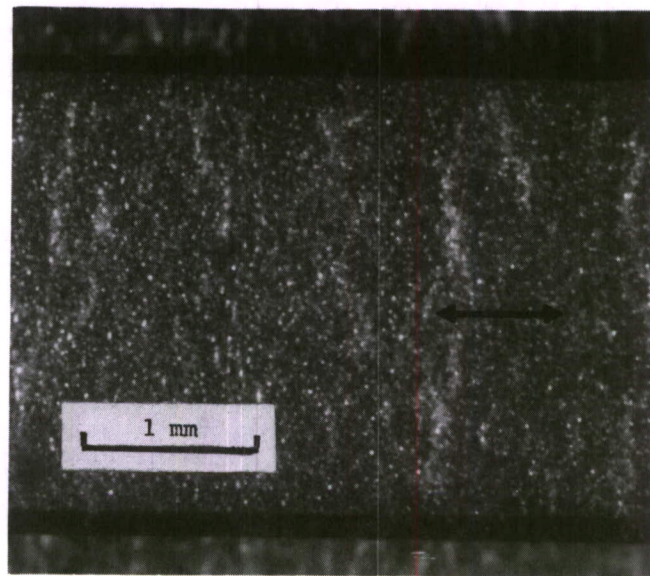
Figure 139. NC 435 STSR sample that was loaded to 296 MPa and failed at 22 hours at 1300 C. The flat tensile face is shown and lateral creep cracks are evident. Tensile bending stresses were in the direction indicated by the double arrow.
